Rail Defect Management

Richard Keefe
IEM(TKE)
(Then Permanent Way Manager - Operations)

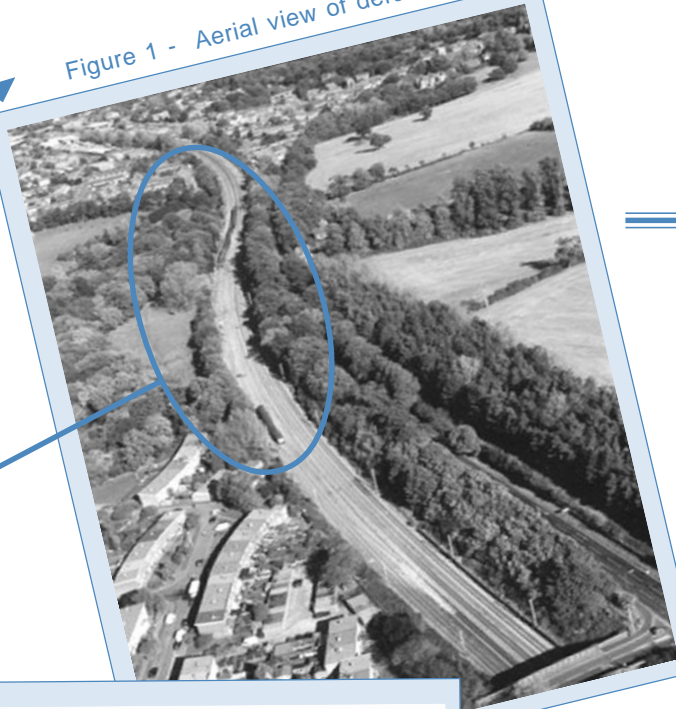
Figure 1 - Aerial view of derailment site

Four people were killed on 17 October 2000 with 30 others injured when a 11-car Great North Eastern Railway train derailed at Hatfield Station, 16 miles north of London (see Figure 1). Set off at 12:10, the London King's Cross-Leeds Intercity 225 was carrying about 110 people, including 10 staff, and travelling at or close to the line speed of 185 km/h.

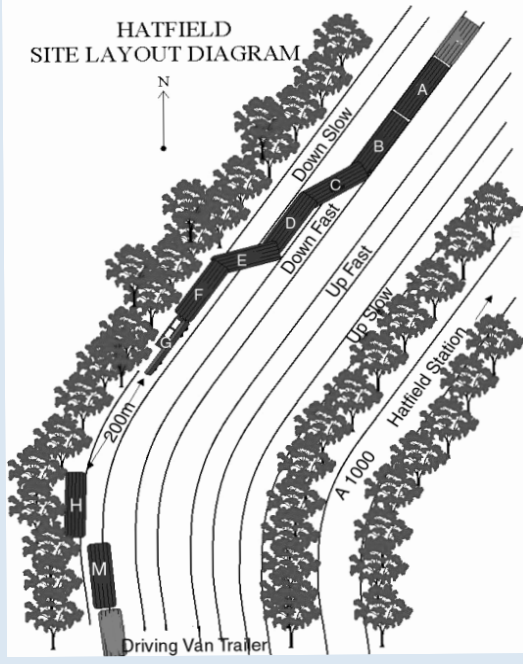
Figure 2 - Derailment site layout

The train was heading North when the locomotive (see Figure 2) with coaches A and B passed over the site of the rail failure which had caused coach C to derail. As the train derailed, coach H was separated from the rest of the train with coach G slammed into an overhead line mast killing four passengers. All other passengers and staff escaped with injuries only.

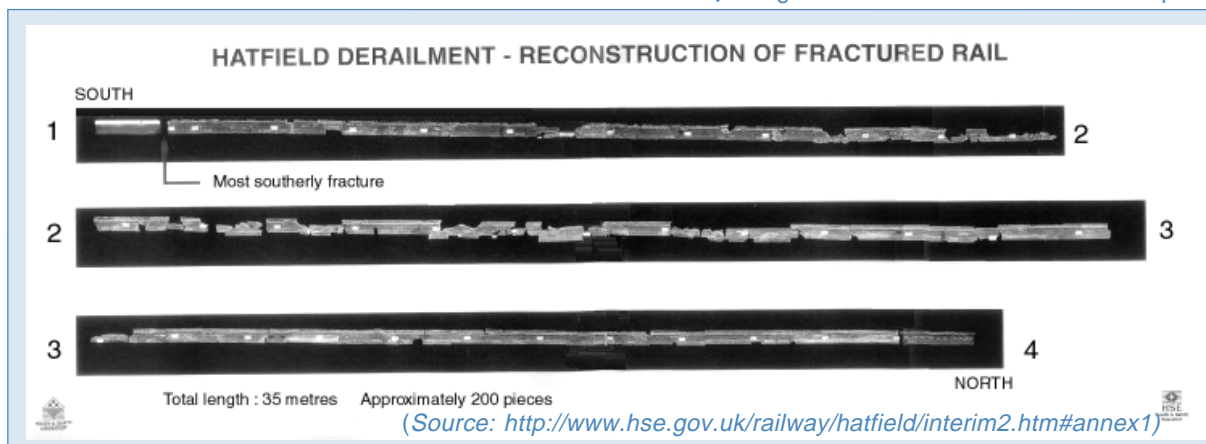
A 35 m section of the broken rail was recovered which had shattered into more than 200 pieces (see Figure 3). Such a failure was unprecedented and there was evidence showing the rail had developed severe gauge corner shelling prior to the derailment and had been weld repaired and identified for renewal. The rail was a premium “mill heat treated” (MHT) rail, commonly used in areas of high demand.

▼ Figure 3 - Rail broken into over 200 pieces

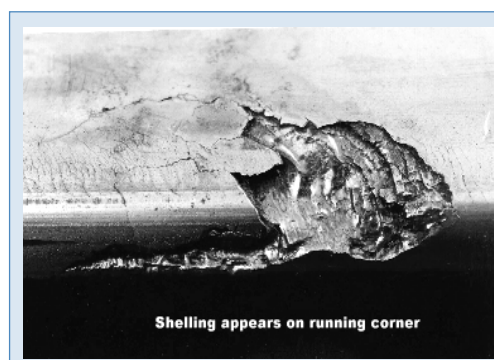
Investigation showed that the broken rail was due to rolling contact fatigue which is usually the result of high stresses at the wheel rail interface contact patch caused by poor matching of wheel and rail profiles. Micro cracking of the rail surface occurs and lubricant leaks into these cracks which has developed further due to induced hydrostatic bursting forces. This causes gauge corner shelling (see Figures 4 & 5).

▼ Figure 4 - Gauge corner shelling

MHT rail which is harder than standard grade rail can be more long-lasting if maintained effectively. MHT rail has been successfully used in the MTR System for at least the last 5 years and an effective rail grinding regime has been implemented through the application of MTR's Rail Management Model (RMM) to prevent RCF problem from occurring. Rail life of MHT rail in MTR shows a 40% increase over the standard grade rail.

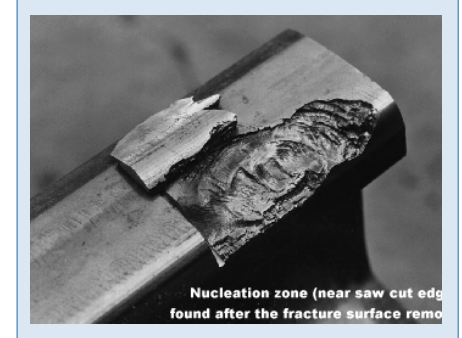
Figure 5 - Shelling fracture surface

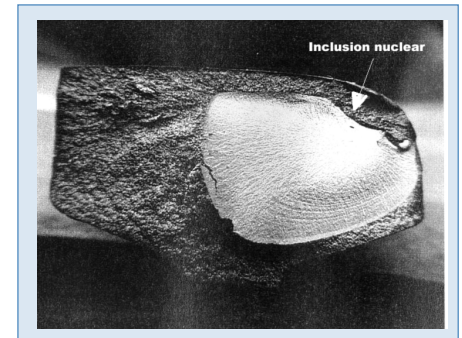
Another type of rail defect found in the Hatfield incident was "tache ovale" (see Figure 6). It is caused by the development of sub-surface shear cracking of the rail head, typically at 5-6 mm below the surface.

The tache ovale can be developed from a nucleation point, either from surface shelling (see Figures 4 & 5) or from an inclusion in the rail. In Figure 6, there is a microscopic particle of slag in the rail acting as the nucleator. The only method of detecting tache ovale prior to any rail breaks is by means of ultrasonic testing.

Figure 6 - Tache ovale, with nucleation point
